Influence of the Results of Verification Calculations of the Building on the Comprehensive Examination and Determination of the Technical Condition of the Bearing Structures of the Building

The article is devoted to the influence of the results of verification calculations of the building on a comprehensive examination and determination of the technical condition of the supporting structures of the Dolgorukov-Bobrin'sky urban manor, 2nd half of the 18th century - 19th century. The main house, 2nd half of the 18th c. - 19th c. XVIII c., 1793, 1819,

1853-1856, located at the address: Moscow, Malaya Dmitrovka Street, 1, building 1.

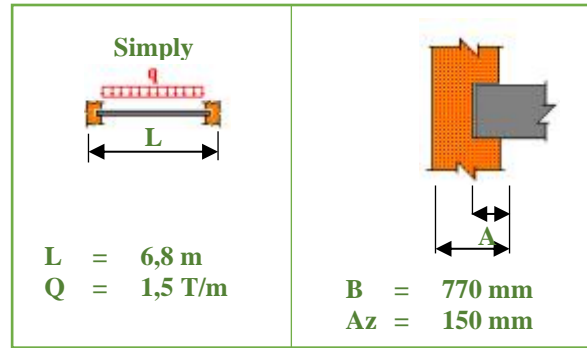
Fig. 3 Determination of the coefficient of utilization on the buckling of masonry partition Pr-1

Calculation		
Tested by SNiP	Test	Utilization
Para. 7.13 SP 15.13330, para 7.3 Designer's guide	by crushing brickwork under the beam support	3.01

Utilization rate 3,011 - By crushing brickwork under the beam

- The bearing capacity of the brick wall of the basement in axes A-B/3 is not provided; the utilization factor is more than 1.5;
- The bearing capacity of the walls under the action of longitudinal forces is ensured; the coefficient of bearing capacity use is 0.71;
- The bearing capacity of the walls in the buckling under the supports of the beams is not provided; the coefficient of bearing capacity is 3.011 - walls on the axis of the V-D/4.
