On the Landslide of Daigala Slope-Kurdistan-Iraq

Assist. Prof. Dr. Hamed M. Jassim^{#1}, Dr. Zahra'a Noori Rasheed^{#2}, M.Sc. Bahra Dhahir Ghafour^{#3},
Dr. Faris Rashied Ahmed^{###4}

Abstract— The strategic two-lane road (Erbil – Koya) is the main link between Erbil and Suleymaniya governorates. It passes through Daigala bridge whose edge from Koya side is adjacent to a curved section which experienced a slope failure (Fig. 1) in the form of rotational sliding which progressed into a slump failure through the mechanism of “progressive failure” after the overburden soil and sediments were fully saturated with water due to some heavy rain storms which happened at the end of January 2013 leading to the loss of cohesive force and triggering that failure which was developed into a progressive failure by the action of additional loading which was imposed by the heavy traffic of big oil tankers which were running on the adjacent paved road.

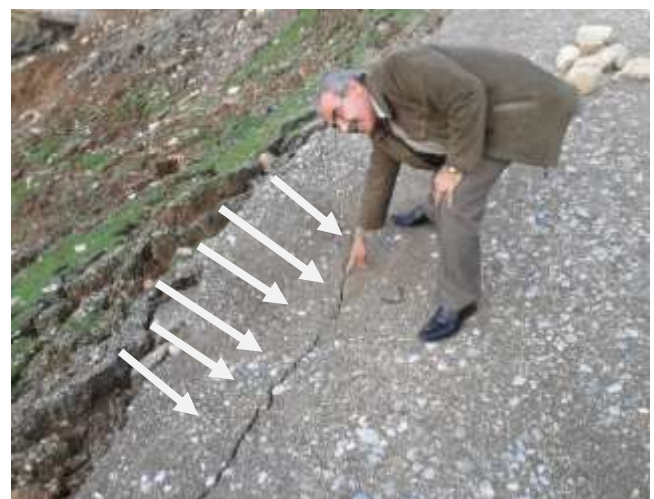
The research team had intervened at the traffic police authorities who were present at the site by giving an advice of closing the lane of the road closer to the landslide and doing some remedial actions to stop and freeze this progressive failure. The effect of this failure on the paved road is clear in the development of tension crack at the edge of the paved road [see white arrows in the following picture], (Fig. 3) and also (Fig. 4), taken on 3.2.2013) which illustrates the later effect of the slope failure on the foundation of the electricity post standing adjacent to the failed slope in the form of a crack progressing in the direction of the slope (white arrows):

Fig. 3: The Start of crack development on edge of paved road due to progressive failure.

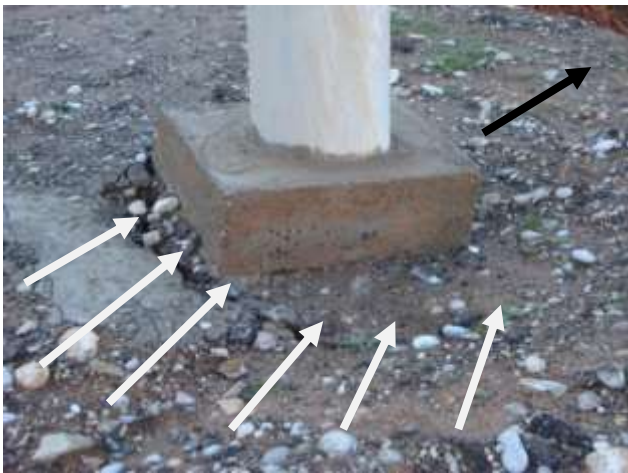
Fig. 4: The development of a crack at the foundation of electricity post due to progressive failure.

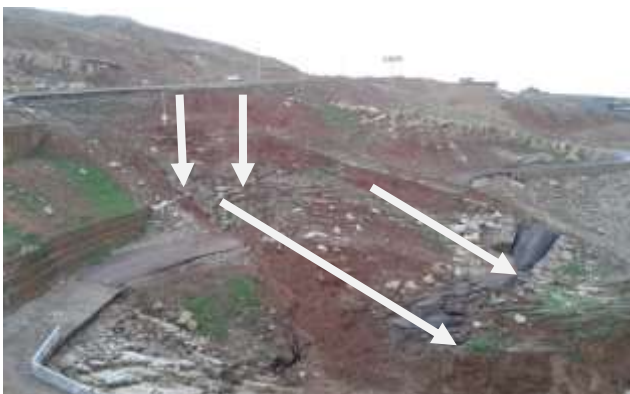
The slump failure resulted in a downward movement of the curved saturated block of sediments pushing and cutting, on its way, the lower emergency paved road leading to a considerable partial displacement to a section of this lower road making it inaccessible as shown in the following Fig. 5, as marked by the white arrows:

Fig. 5: A view of the failure and the damaged lower road (white arrows).

- 1- The disturbed blocks have to be removed and different measures of slope stabilization have to be made.
- 2- The water infiltration rate has to be reduced by installing horizontal drainage pipes at different locations across the slope face. These drainage pipes have to be of various lengths to cover most of the slope section and the perforated part at the far ends of the pipes have to be long enough to secure efficient drainage.

- 3- The toe parts of the slope have to be supported by installing some form of key structure to act as retaining element.
- 4- Application of soil nailing at the most critical locations of the slope in order to prevent the horizontal sliding of the slope.

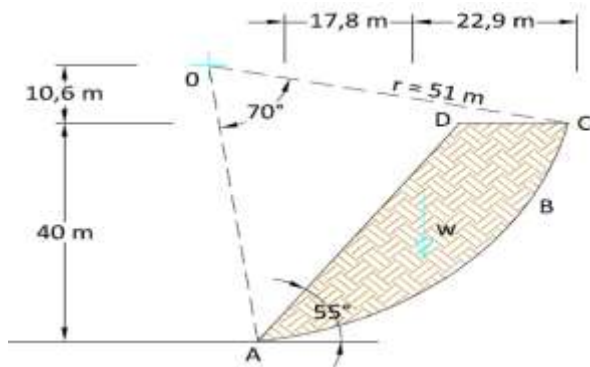
Our Case: From the geometrical measurements which were taken at the site (illustrated in the figure below) and the necessary values from laboratory tests (illustrated in the table below), the following procedure has been used to analyse the slope failure and to calculate the slope factor of safety (F):

Cross-sectional area ABCD is 673 m².
 Weight of soil mass = 673 × 19.55 = 13,157.2 kN/m

The centroid of ABCD is 17.8 m from O. The angle AOC is 70.0° and radius OC is 51.0 m. The arc length ABC is calculated as 62.6 m. The factor of safety is given by:

$$F = \frac{C_u L_a r}{W d} = \frac{59.7 \times 62.6 \times 51}{13157.2 \times 17.8} = 0.813$$

- 3- The calculated minimum factor of safety of the slope was calculated, based on the existing geometrical parameters and material properties and characteristics and found to be 0.81 which explains the failure which happened and its development.
