Remaining Life Assessment and Corrosion Rate on Storage Tank Using ASME/FFS-1 A 579

The equipment to be studied is the Oil Storage Tank belonging to PT. XYZ with low carbon steel A 36 material. The equipment was chosen because the operation of the storage tank has exceeded 15 – 25 years. (22)

Residual Life Assessment for Storage Tanks (T-106) evaluates the integrity of the storage tanks and the calculation of the remaining useful life by processing and analyzing construction data and the results of the last inspection in the field. The data obtained are specification data and technical information about equipment, visual observation data and thickness measurement data. The data obtained from the inspection results will be processed into data input in conducting the Residual Life Assessment. The methodology for conducting the assessment is divided into three methods. Evaluation of the strength of the equipment referring to API Std. 650, API Std. 653 & API 579-1/ASME FFS-1.

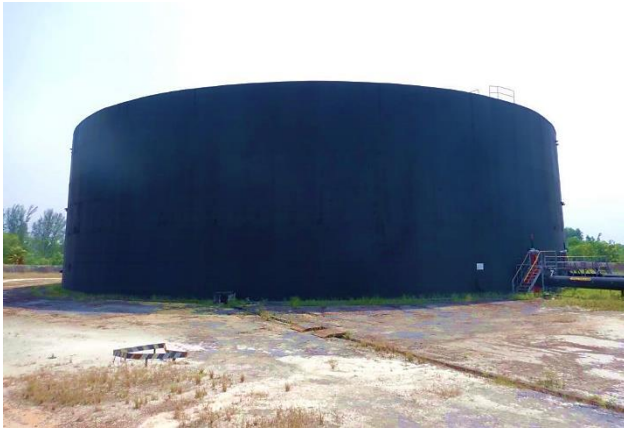
Fig. 2 Storage Tank T105

In general, the storage tank T-105 is in good condition and suitable for operation. The paint coating on the storage tank is still relatively good. Only wild vegetation grows around the storage tank; it is enough to clean it. This visual check process only describes the external condition of the storage tank; internal checks cannot be carried out because the storage tank is in an in-service condition. The inspection rules must carry out internal checks in API 653.

In PT XYZ's T-106 Storage Tank, no significant anomalies were found during the inspection that might affect the storage tank's ability to continue operations safely. However, it is recommended to maintain the condition of the storage tank so that it remains in its service function.
