# Retrofitting Analysis of Steel Roof Frame to Preserve Heritage Building 1921

**Abstract** - The spirit of preserving heritage buildings as they originally became a big challenge during design analysis, ensuring they remain in their original state without damaging the construction process. The objective of this research was to maintain the authenticity of the structure. Roof covering, strengthening and detailing the roof by analyzing the structure on the roof's strength, stability, and deflection with Indonesian code 1729-2015 based on the American Steel concept. Analysis of dead loads, live loads, and the wind load, because only the roof was on the 3rd floor and the roof slope is 30°. The case study method was carried out with surveys and secondary data results from the investigation consultant in 2016. The analysis results of two truss members' roof, 2L 70.70, need to be replaced with a double profile 2L 80.80, bolt connections with the provision that steel profiles, bolts, and rust anchors were replaced. Analysis of the 3-dimensional roof structure with software by calculating the compressive wind load of 75.82 kg/m<sup>2</sup> and the suction wind load of 57.37 kg/m<sup>2</su

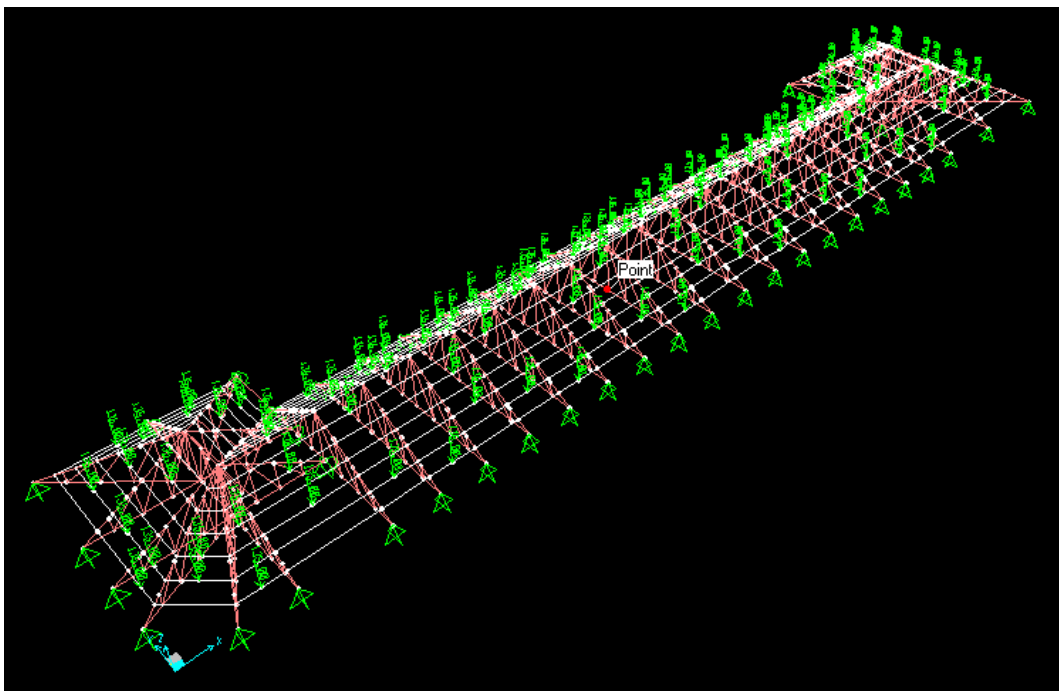
Fig. 6 SAP2000 Program, live load input (Researchers Team)

According to Figure 5,6,7,8, the load entered in the structural software is:

1. Dead Load 157,64 kg/m<sup>2</sup>
2. Live Load 135 kg/m<sup>2</sup>
3. Push Wind Load 75,82 kg/m<sup>2</sup>

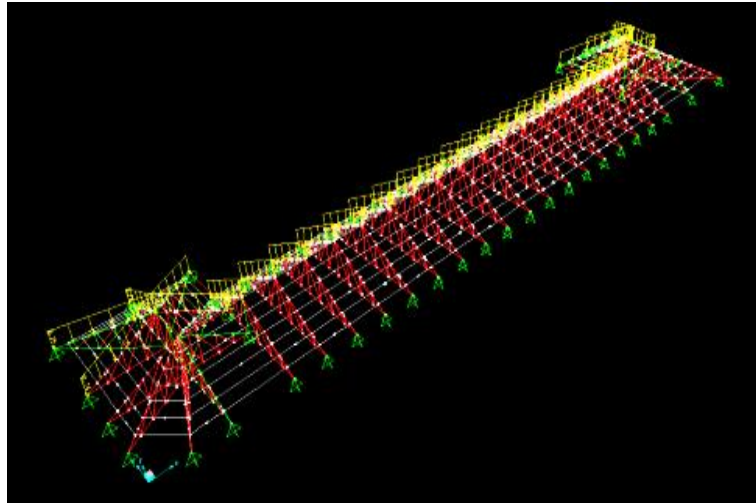
Fig. 7 SAP2000 Program, push wind load input (Researchers Team)

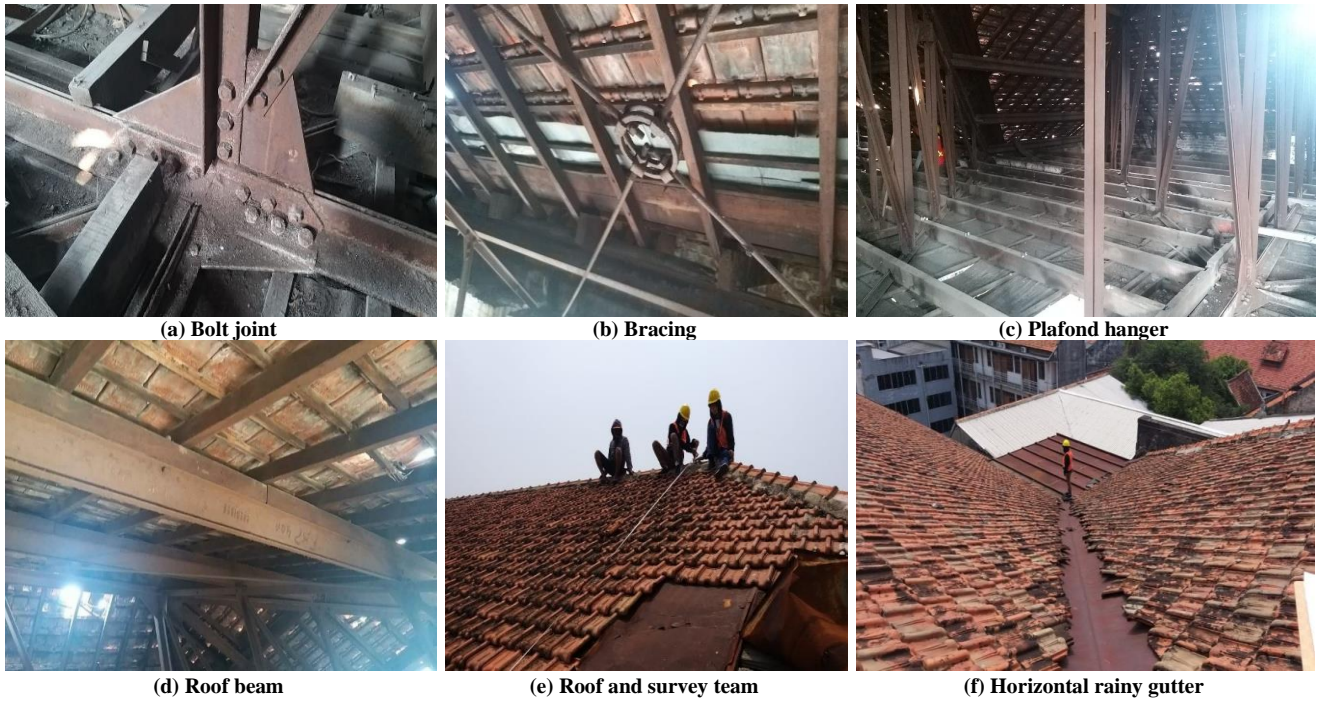
Fig. 11 (a), (b), (c), (d), (e), (f), (g) Existing detail roof structure and roof

A small part of the roof truss elbow profile is porous in areas not protected by the roof, so it must be replaced. The roof beam WF profile, which is porous, is still good and is considered to have been replaced according to the dimensions of the existing roof truss. The input software is assumed to be non-rotten and non-hollow because it will be replaced with a new steel profile.

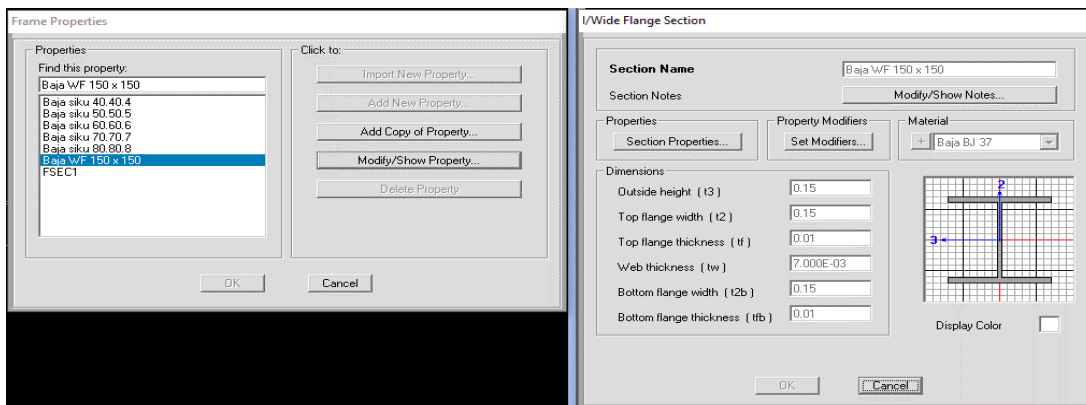
Fig. 23 Dimension of steel material IWF

Input material dimension Figure 22. 23 at below

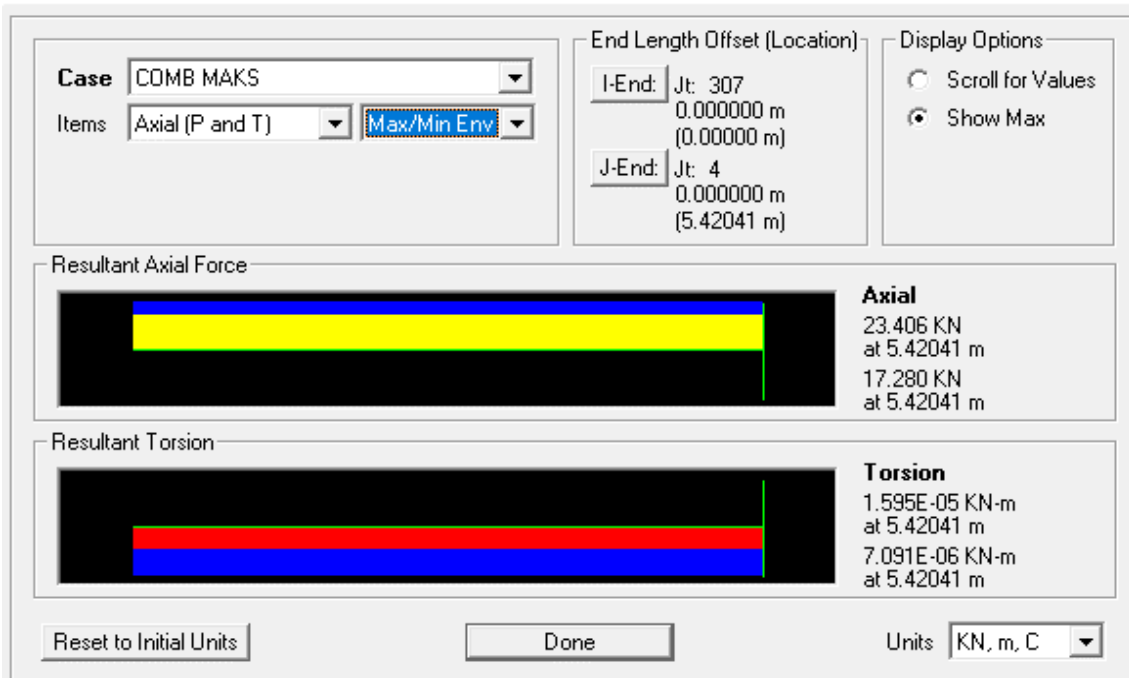
- Double elbow steel profile 40.40.4 span L=5.42041 tension  
Double elbow 40.40.4 Member no 581 biggest force  
P max elbow 40.40.4 output software = 23.41 kN, yes, it safe

Diagrams for Frame Object 581 (Baja siku 40.40.4)

Fig. 27 Axial force. Double elbow steel profile 40.40.4

Number of profile bolts needed 40.40.4: (23.41)/(34.63) = 0.67 → 1 piece min 2 pcs, tensile bolts.

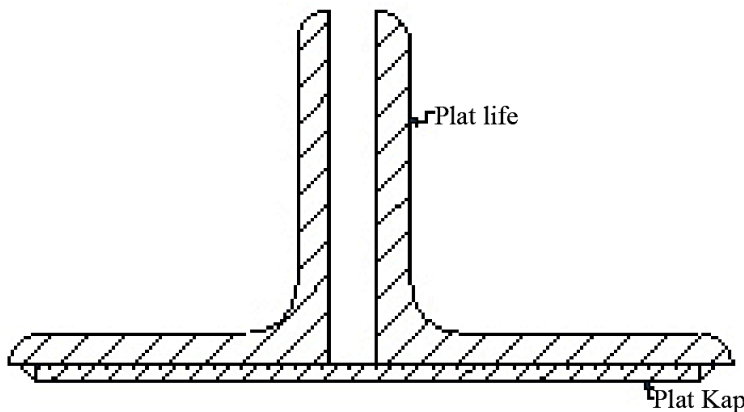
Connecting plate thickness:  $t_p = 8 \text{ mm}$

Source: Author AutoCAD drawing

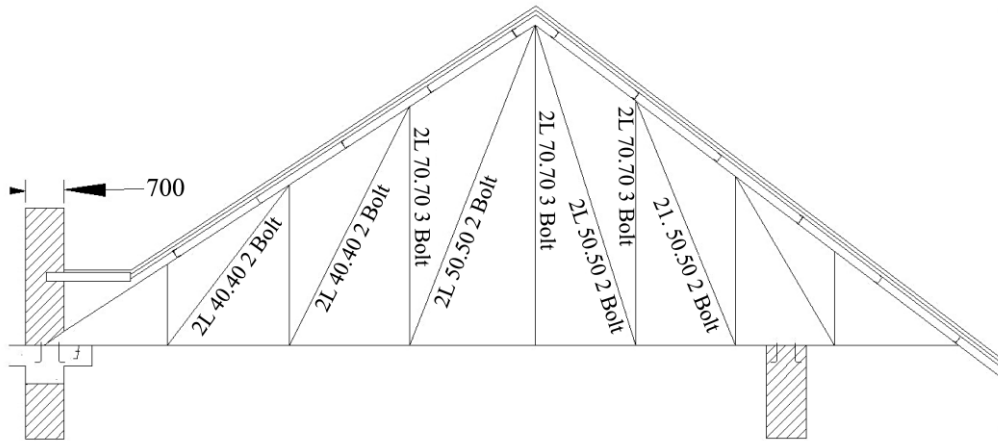
Fig. 30 Bolt requirement on profile

The highest number of bolts required in the profile 2L 80.8.8 J 127.95 kN 2L 80.8.8 : : (127.95)/(45.47) = 2.813943 = 3 bolts. There are a maximum of 3 installed existing ones, while the others only need 2 bolts with a diameter of 13.

Several bolts are required for profile 2L 70.70.7: = 2.67 → 3 bolts Existing bolts 3 bolts for each connection. Several other bolts are required on 2L profile 70.70.7: = 1,958 → 2 bolts. The number of bolts required for the 2L profile is 70.70.7: = 1.689 → 2 bolts. BT 161 (89. 03 KN), BT 214((76.81 KN).
