# A Microstructural Analysis and In-Situ Infrared Thermography of IS3048 Steel to Assess Drilling Tool Performance

Annavarapu Venkata Sridhar<sup>1</sup>, Balla Srinivasa Prasad<sup>2</sup>, Karaka VVNR Chandra Mouli<sup>3</sup>

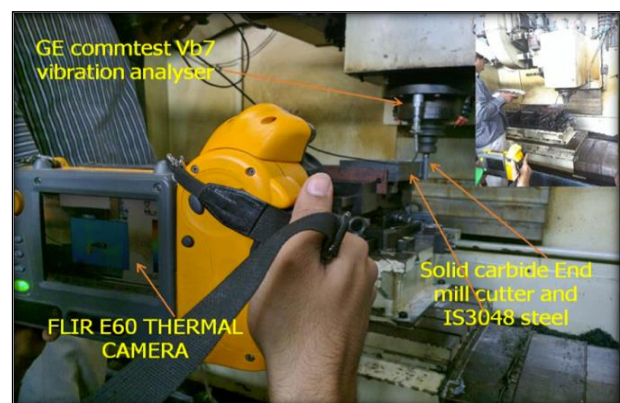
**Fig. 1 Drilling IS3048 Steel in an Experimentation Setup**

Cutting temperatures are recorded using a FLIR E60 thermal infrared camera at a distance of 5 feet from the workpiece and tool contact location as the cutting speed and feed rate change. Spindle speeds ranged from 600 to

1200 rpm throughout the experiments, carried out on a CNC vertical machining focus, as indicated in Figure 1.

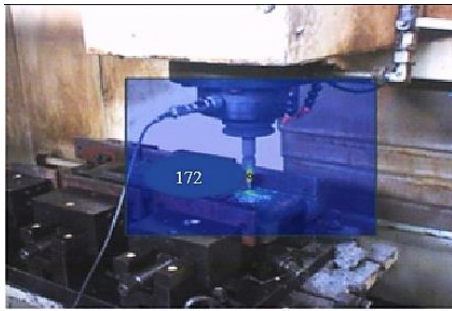
**Fig. 2** TCI,  $T_a = 172.05^\circ\text{C}$

The thermographic images below were acquired using a 7 mm solid carbide tool. As illustrated in Figure 2, the carbide cutting tools used in machining are tested in order to determine their working conditions. Figures 2–7 show the recorded thermal images for Tools A and Tool B under test settings.

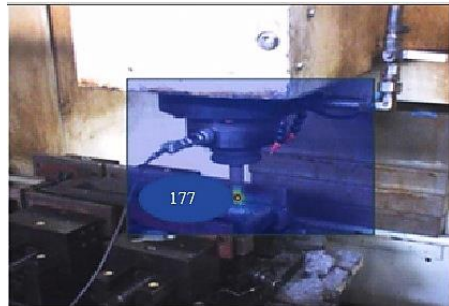
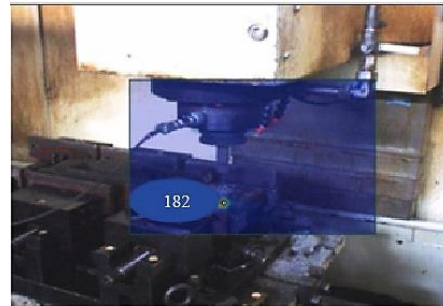
**Fig. 4** TC2,  $T_a = 177^\circ\text{C}$

**Fig. 5** TC7,  $T_a = 182^\circ\text{C}$

TC2 and TC7 test circumstances record temperatures of  $182^\circ\text{C}$  and  $177^\circ\text{C}$ , respectively, Figures 4 and 5 show how the temperature rises with tool diameter and Table 3 cutting parameters. Likewise, for Tool B with a 3mm diameter, Figures 6 and 7 indicate recorded temperatures for TC1 and TC4 test circumstances, where the temperature at TC1 is  $158^\circ\text{C}$ , and the temperature at TC4 is  $165^\circ\text{C}$ . The data clearly demonstrates increases in cutting parameters like speed, feed, and depth of cut. To better comprehend the Tool A temperatures assessment in relation to Tool B, the recorded information is shown in the graphs illustrated in Figures 8 and 9.

Figures 4 and 5 show the temperature spike tool diameter as well as machining conditions (see table 3), which clearly characterizes this relationship.

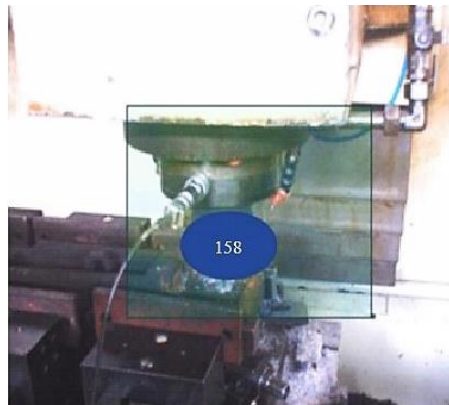
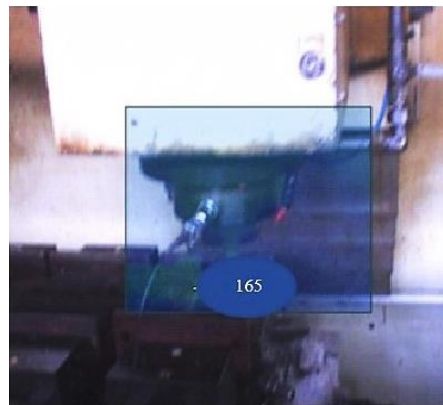
**Fig. 6** TC1,  $T_b = 158^\circ\text{C}$

**Fig. 7** TC4,  $T_b = 165^\circ\text{C}$

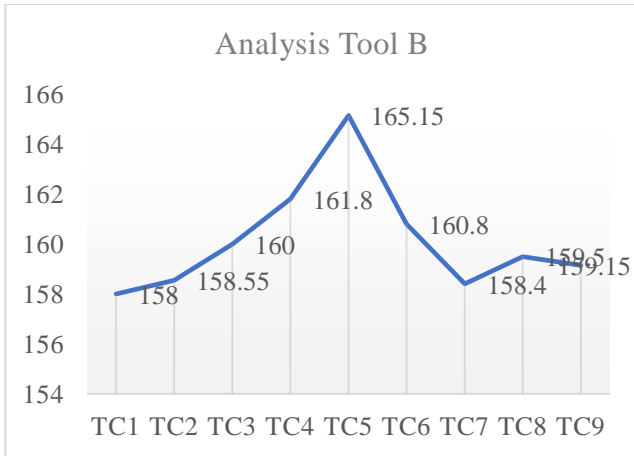
Fig. 9 Analysis of Tool B's Temperature

The curve in Figure 9 is generated using the plotted readings detailed in Table 4 on behalf of Tool B. TC5 has a temperature of 1650C whenever the feed (f) at 0.5 mm, the speed (N) is 9000 rpm, and the axial depth of cut (d) is 12 mm.

The minimum temperature reading is observed at TC1 of 1720C, which is the beginning condition of the tool initiating the drilling operation, as shown in Figure 9. Since the Taguchi L9 Orthogonal array was used to develop the optimum settings, the studies looking at TC5 revealed the greatest temperature during the drilling operation. The temperatures recorded are for a 3mm diameter tool.

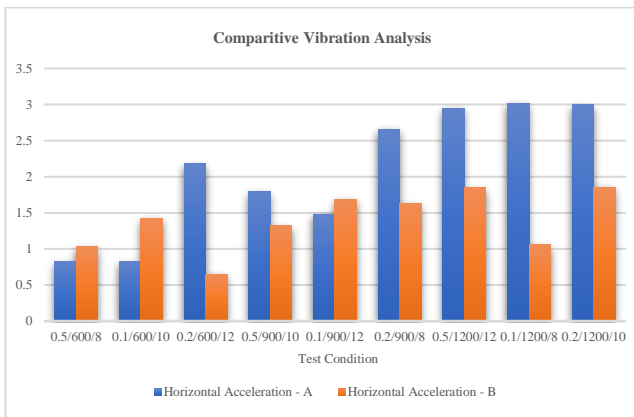
Fig. 10 Tool B's and Tool A temperatures Analysis

As can be seen in Figure 10, Tool A has a substantially higher temperature than Tool B. Because the tooltip is in contact with the workpiece for a shorter period of time with Tool A's 7mm diameter than with Tool B's 3mm diameter, the temperatures are greater.

As seen in Figure 10, Tool A has a significantly greater temperature than Tool B. Tool A's temperatures are higher than Tool B's because the tool tip's engagement with the workpiece is shorter.

Under test settings TC-5 at 161°C and 165°C, correspondingly, with such a speed (N) at 900 rpm, feed (f) at 0.5mm, and cutting depth of 12mm, the highest temperatures obtained for both tools are shown in Figure 10. Under test condition TC1, the starting temperatures of both tools were also determined. The greatest temperature is recorded around test condition TC5 for Tool A, which has a diameter of 7 mm, as opposed to Tool B, which has a diameter of 3 mm.
